### **Field Activity Report**

**RE:** Nuisance Complaint – Elevated Mosquito Activity in the Shore Acres Peninsula and Otter Creek Area, Village of Mamaroneck

**Inspection Dates:** July 27–28, 2026

**Prepared by:** Bob Bellach, Senior Public Health Sanitarian

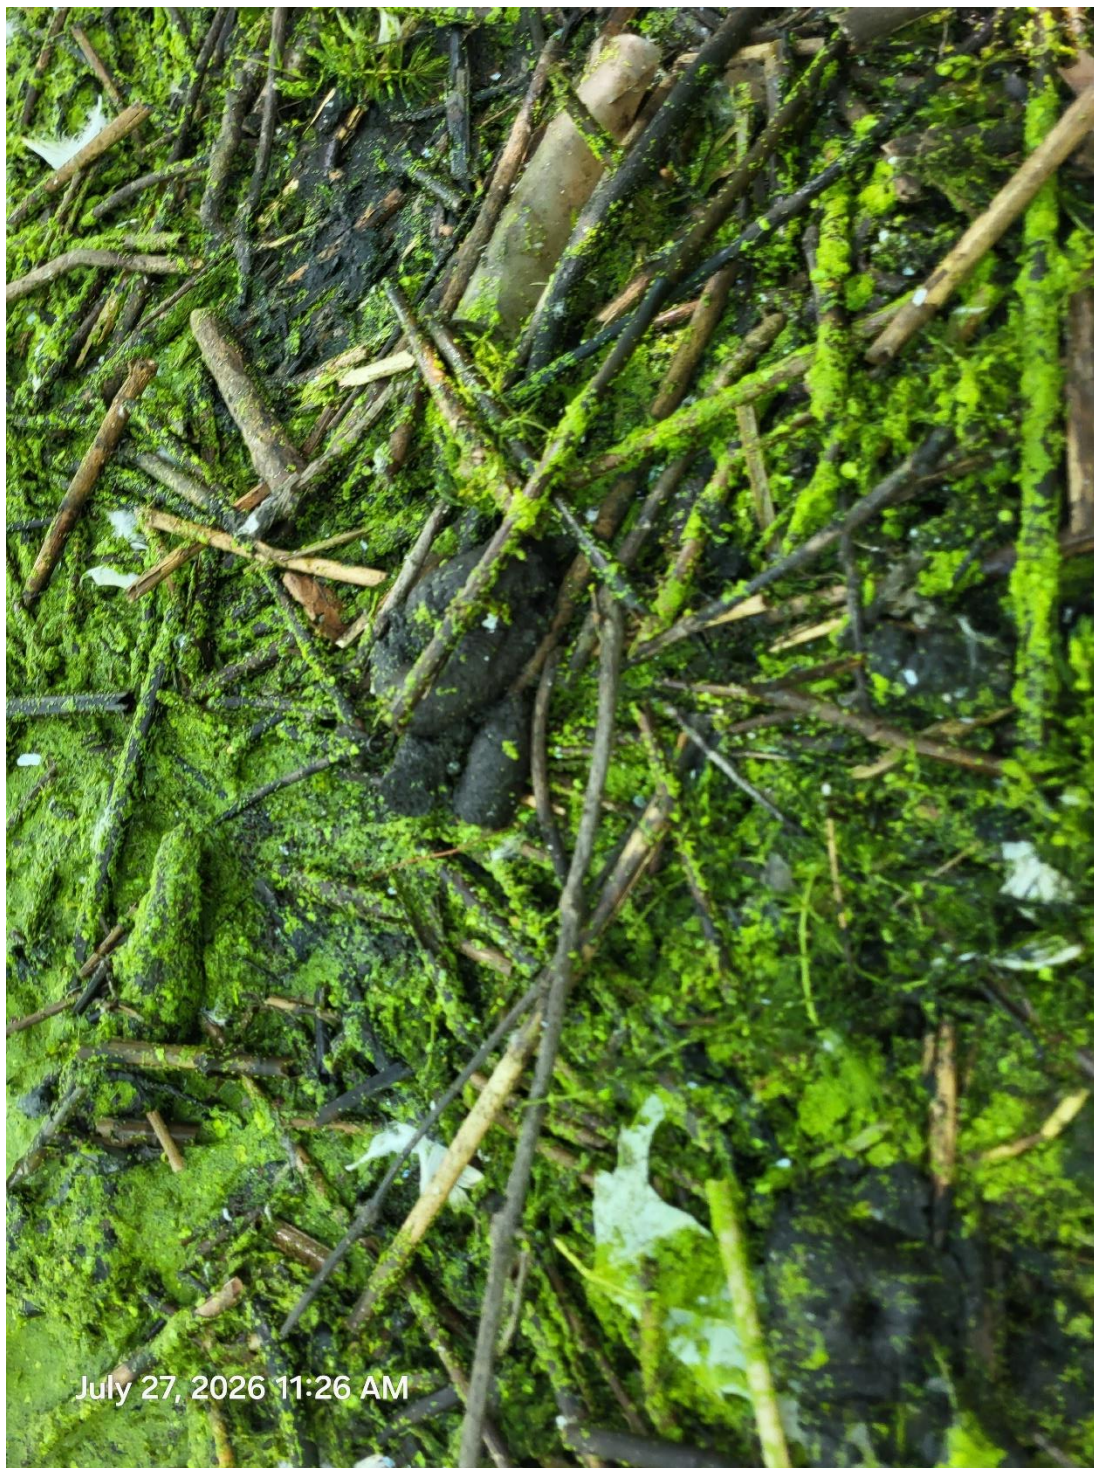
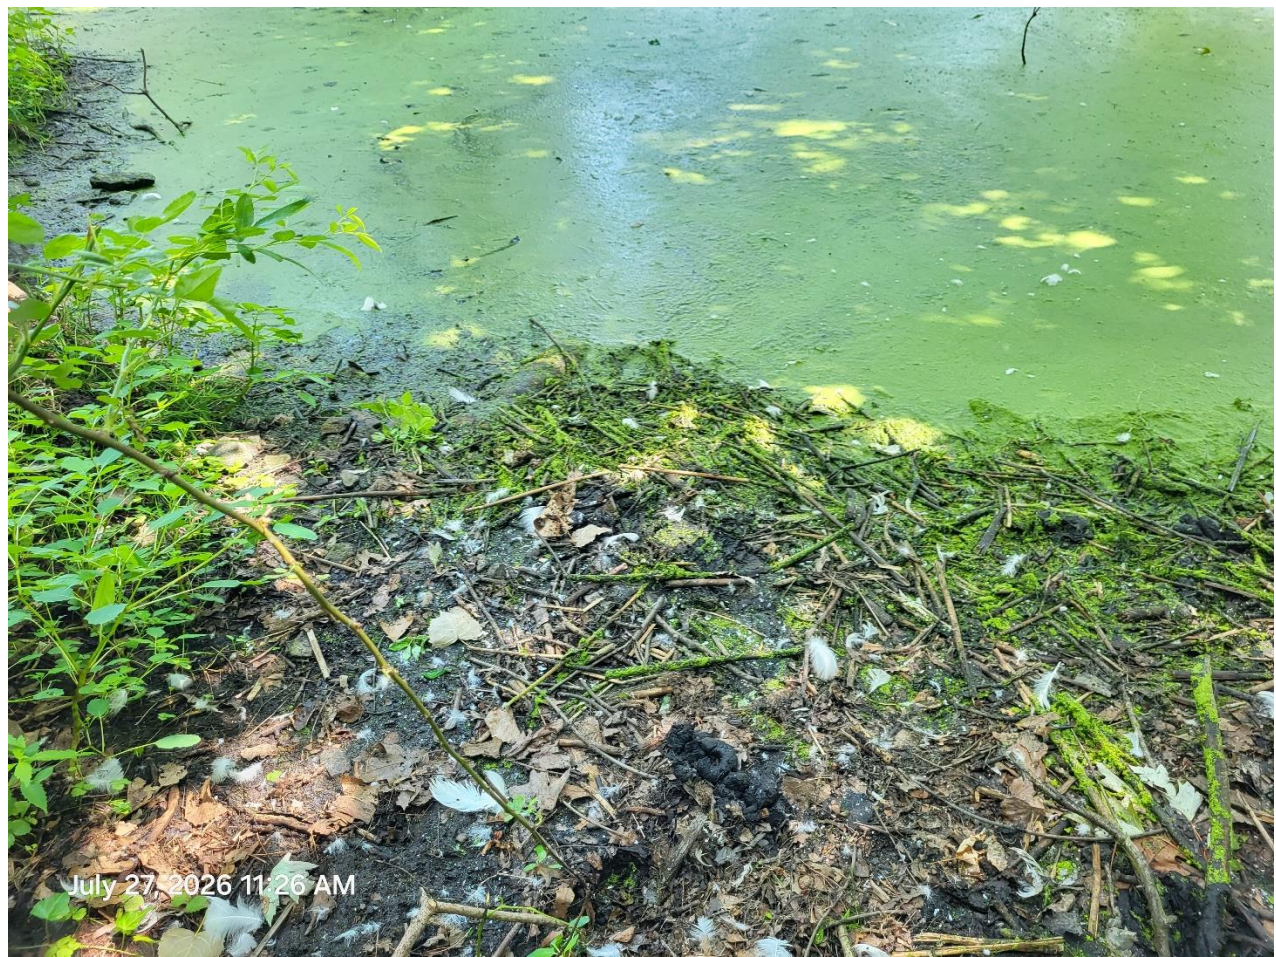
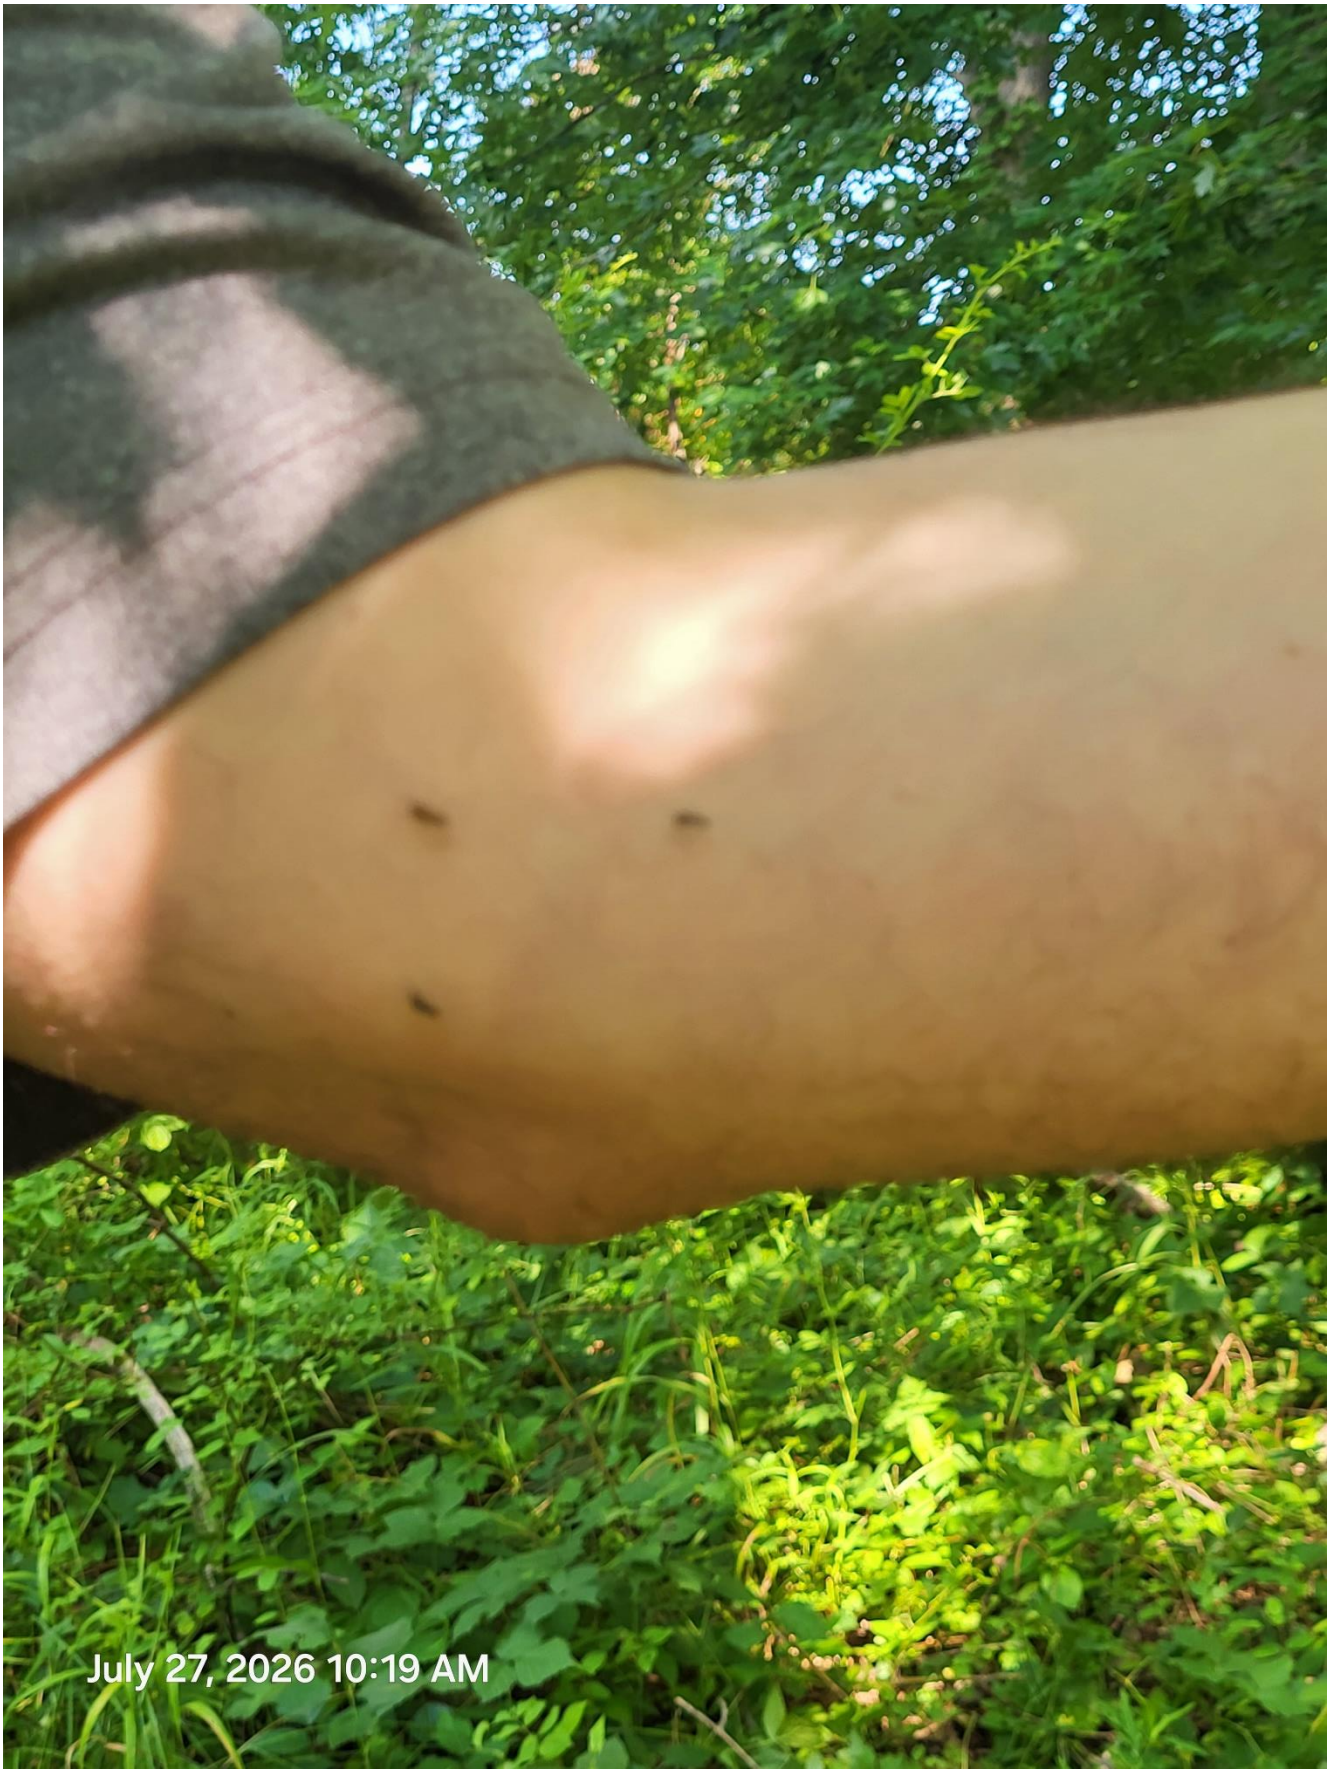
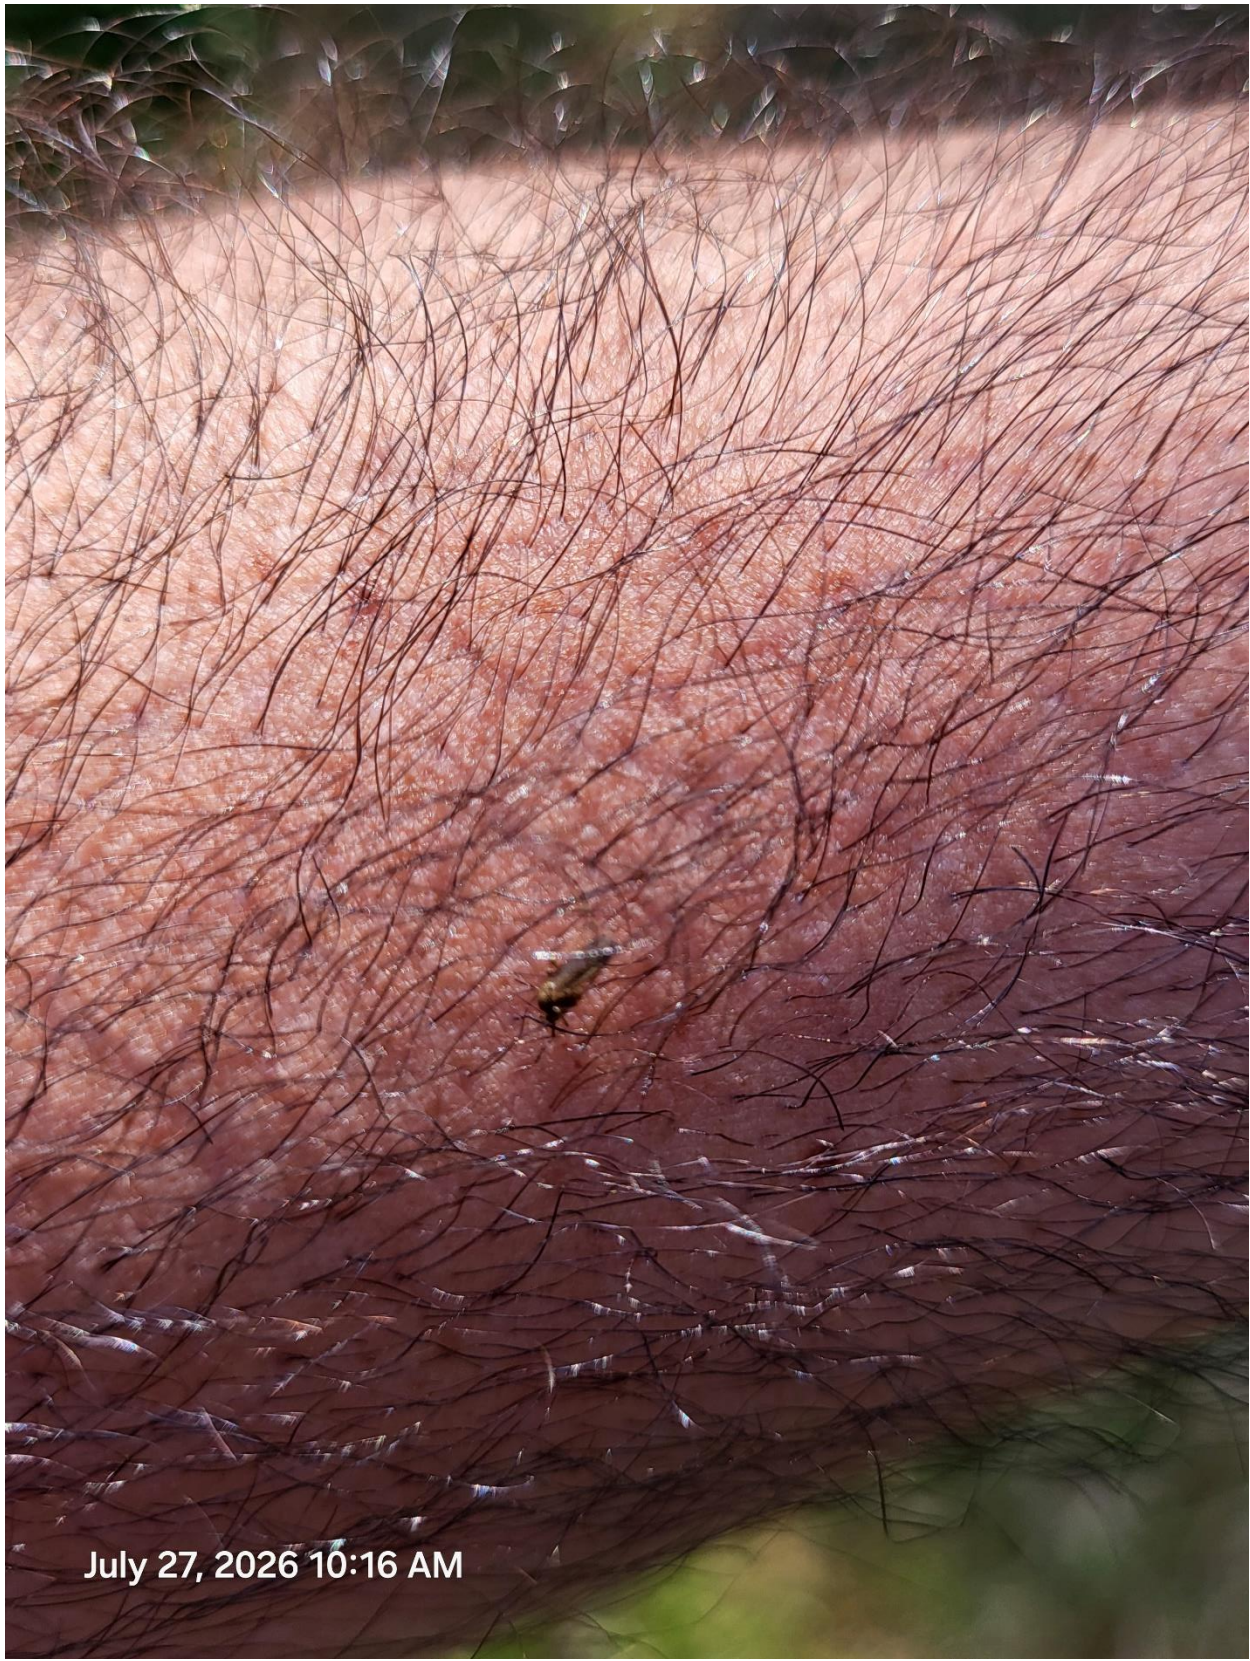
## Sample Site #1 – Wetland Pond

The pond surface was extensively covered with duckweed (*Lemna* spp.). Intermittent gas bubbles were observed rising through the duckweed, suggesting anaerobic decomposition within bottom sediments. Water adjacent to the shoreline appeared shallow, with black-colored water visible during sample collection. A strong organic odor was present.

Mosquito activity at the shoreline was extremely heavy. Notably, inspectors did not observe or hear wildlife typically associated with freshwater pond ecosystems, including fish, amphibians, reptiles, waterfowl, or aquatic insects other than mosquitoes.

Field observations indicate that McGid's Pond may currently function as a stagnant, low-oxygen (hypoxic) or anaerobic water body. The pond exhibited dense duckweed coverage, black-colored surface water, continuous gas bubbles rising through bottom sediments, and a pronounced septic or organic odor, all of which are commonly associated with anaerobic decomposition of accumulated organic material.

Such environmental conditions may reduce or eliminate fish and other aquatic organisms that naturally prey upon mosquito eggs, larvae, and pupae. During the inspection, no fish, amphibians, reptiles, waterfowl, or aquatic insects were observed within the pond. Mosquito larvae, however, are capable of surviving in oxygen-deficient waters because they obtain atmospheric oxygen through a respiratory siphon at the water's surface. Consequently, stagnant, nutrient-rich wetlands with limited biological predation can continue to support mosquito production even when other aquatic species are absent.

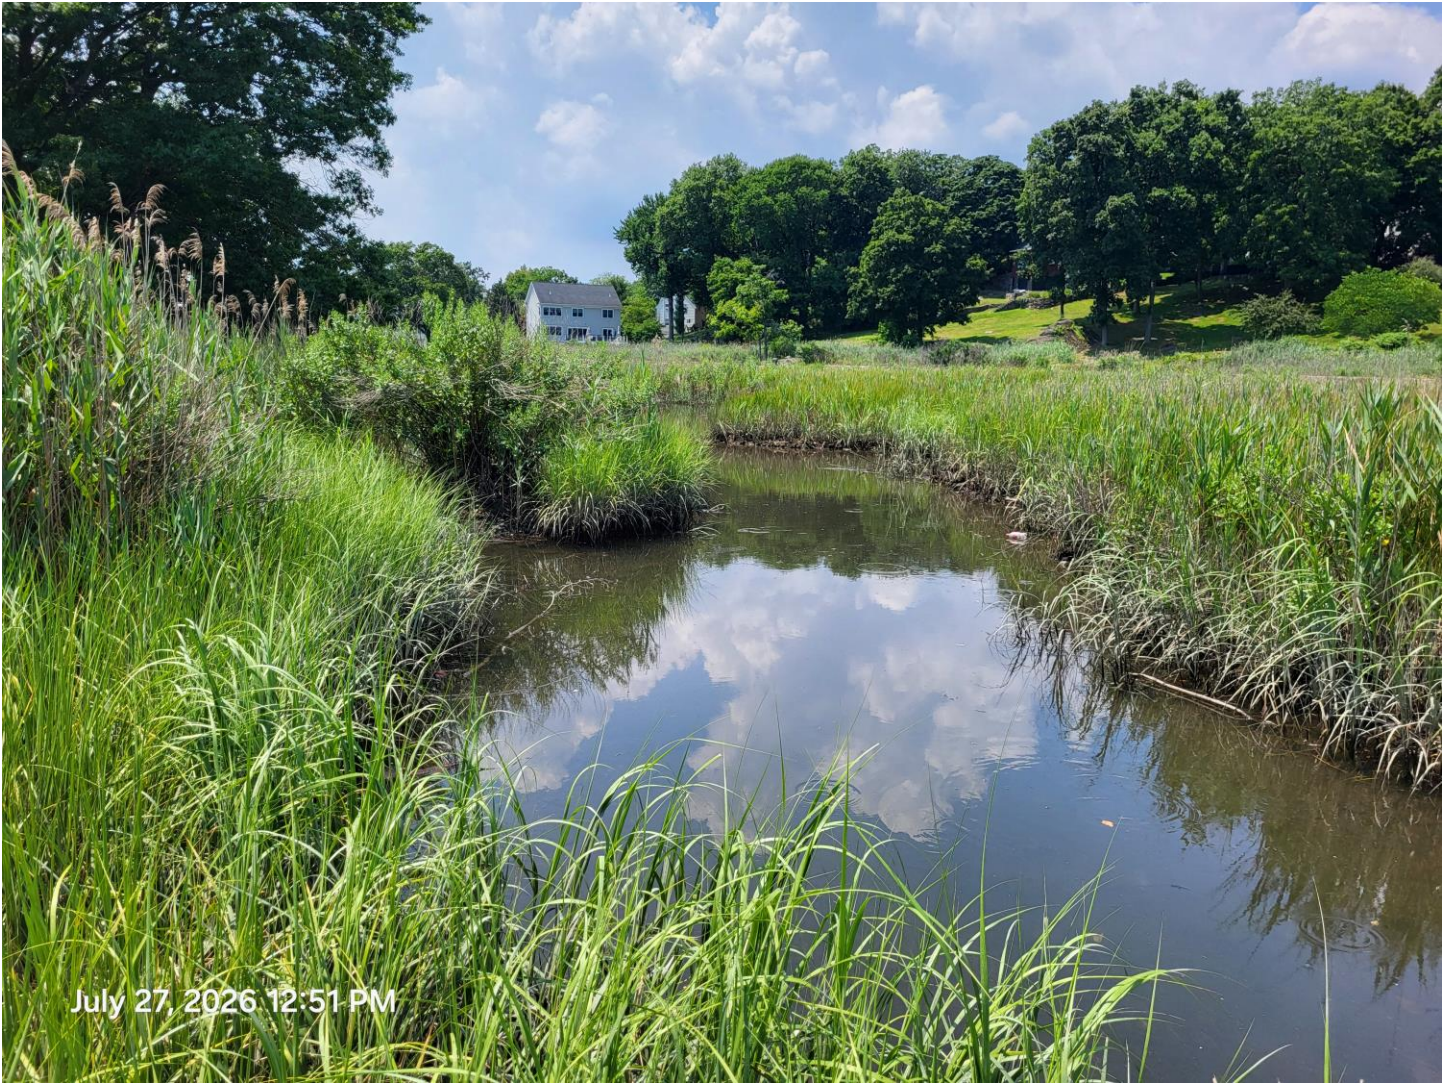
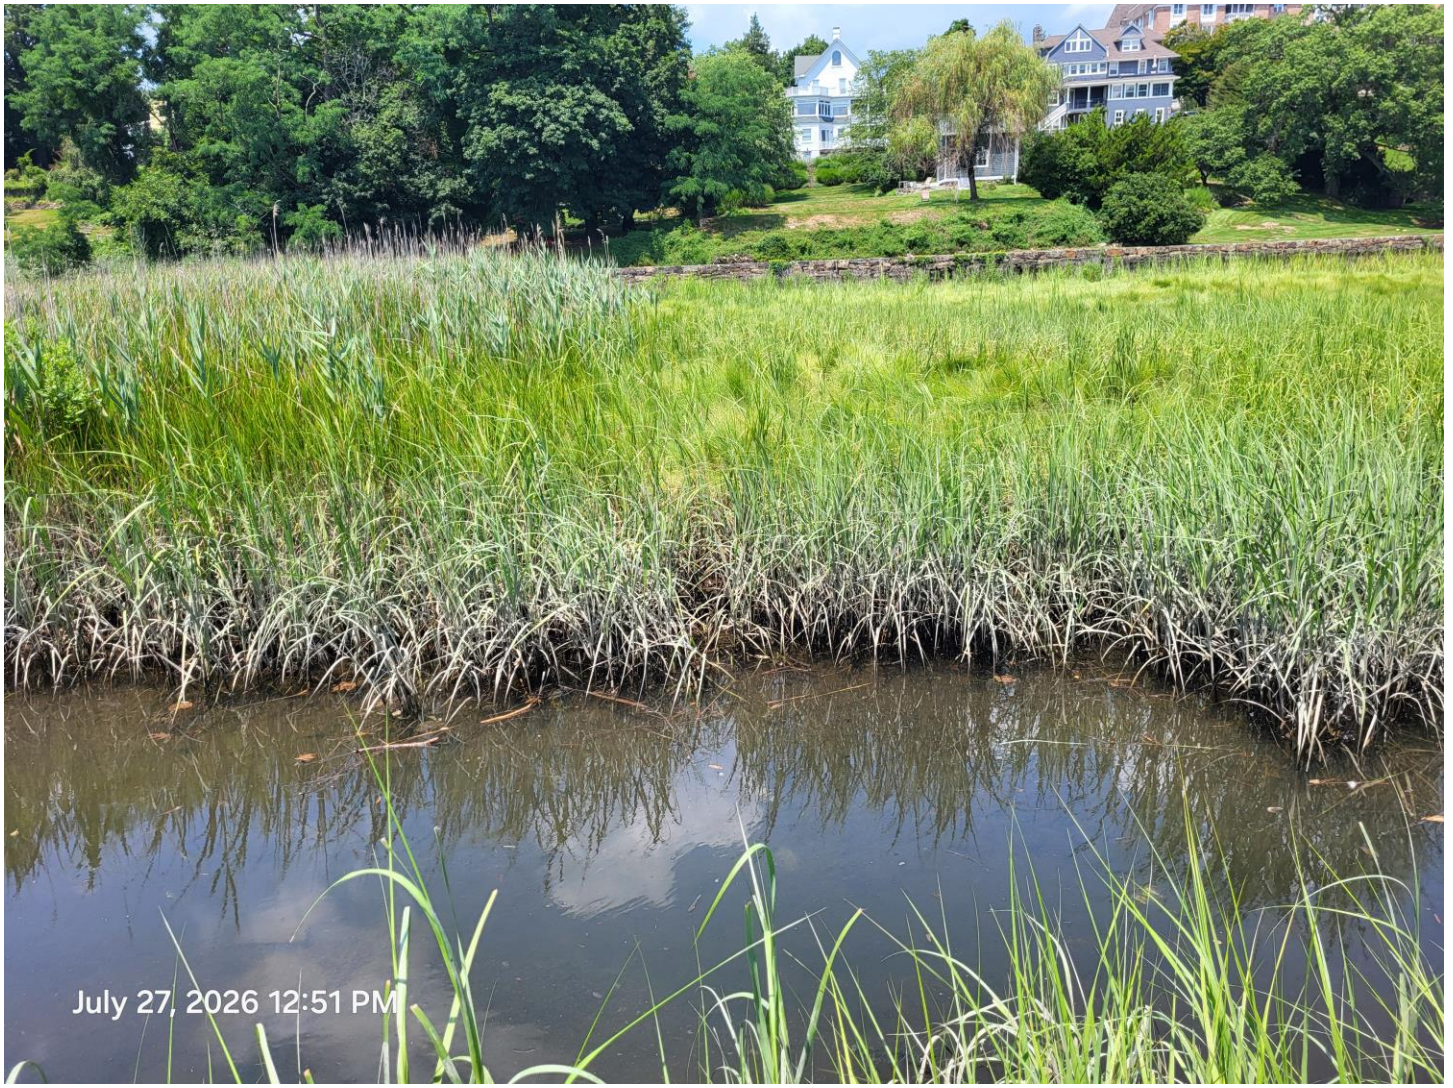
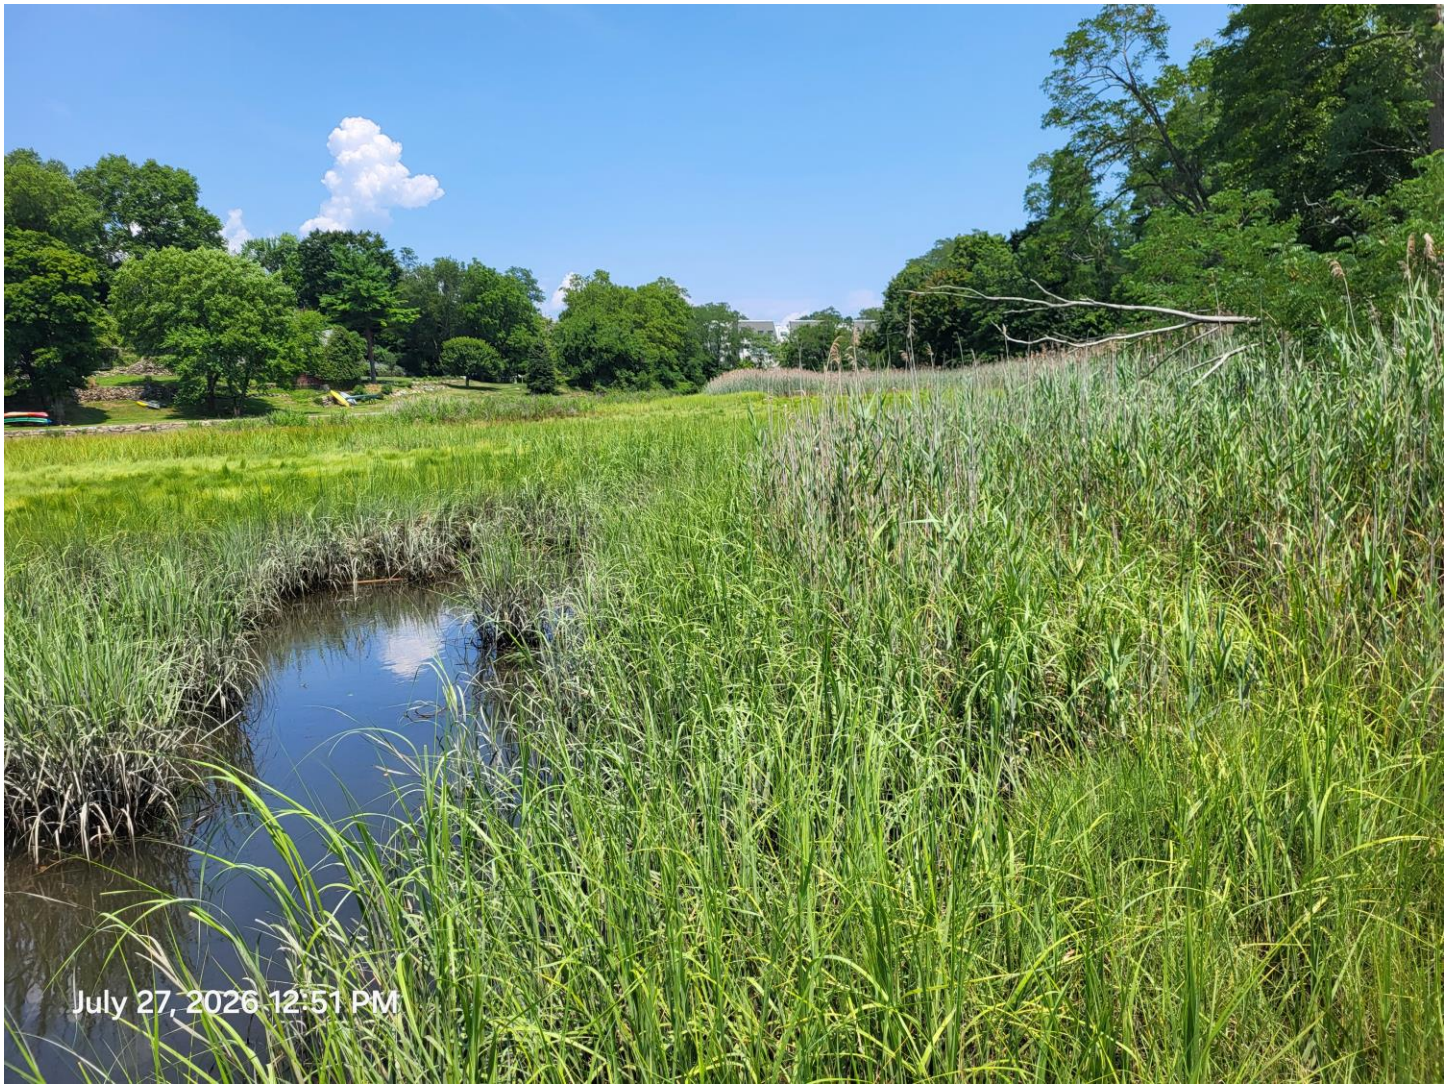
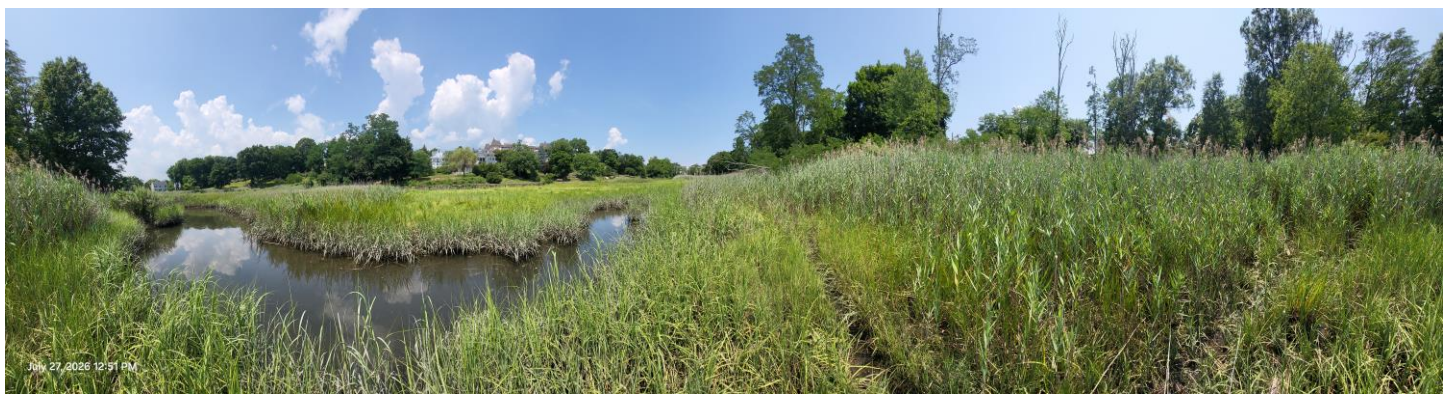
**Sample Site #4 Guion Creek**

A small, slow-moving tributary entering Guion Creek, located west of approximately 925 Shore Acres Drive, was identified and inspected. Mosquito activity remained elevated throughout this location. A surface water sample was collected for laboratory analysis.

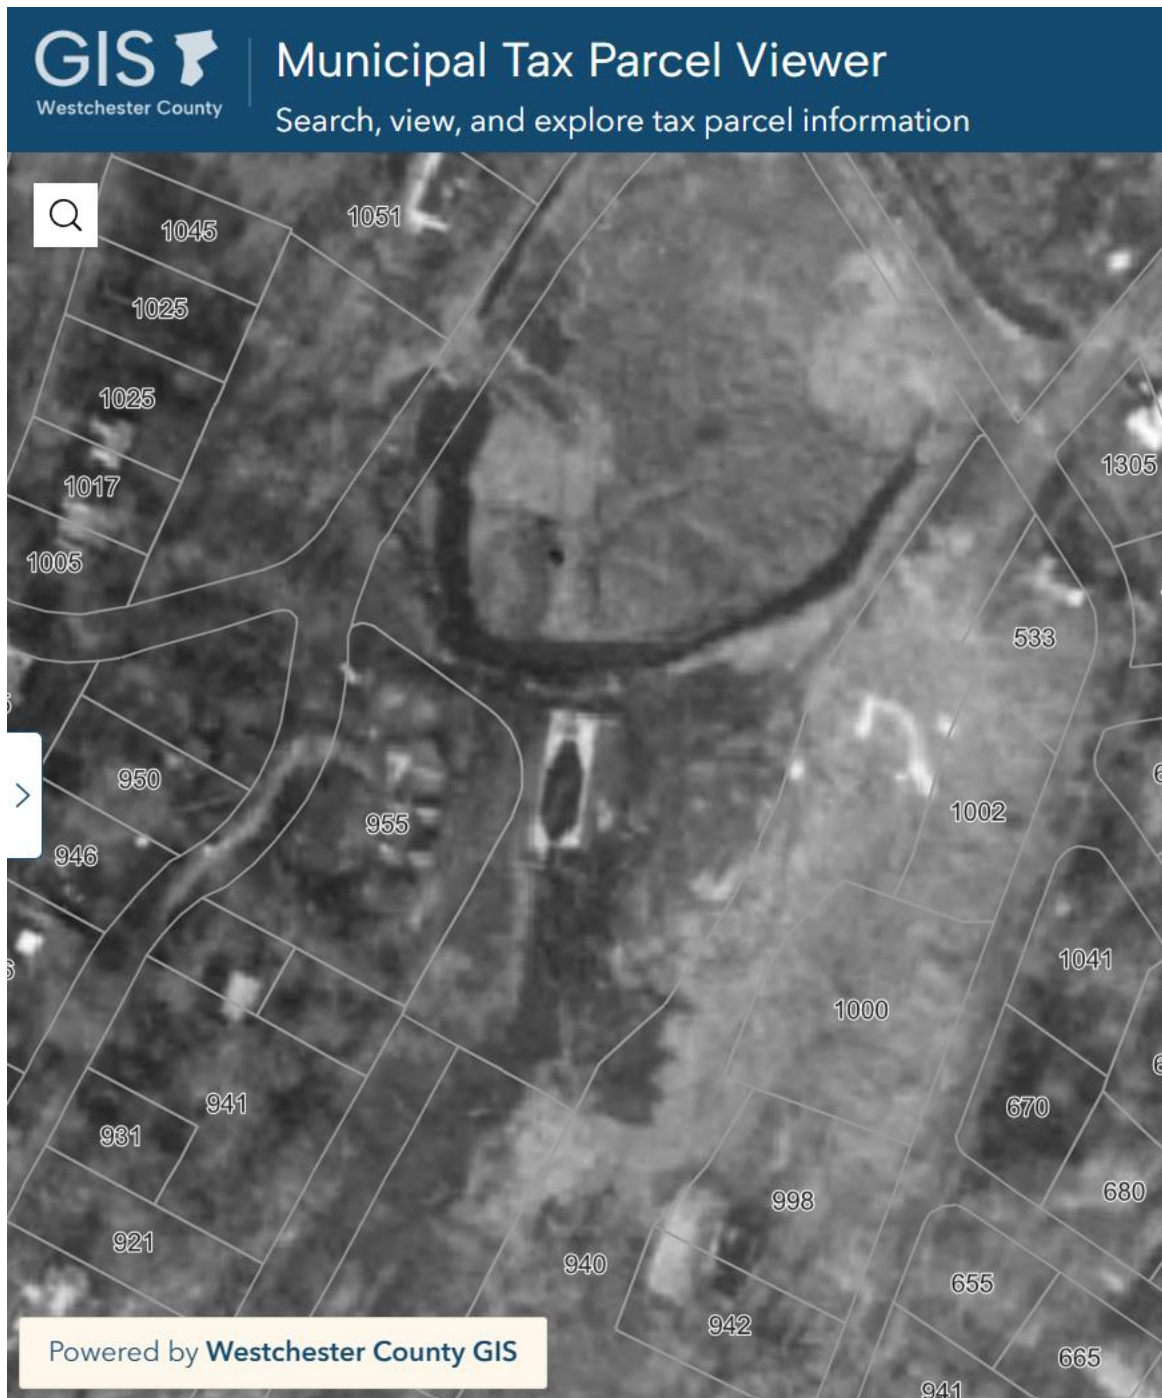
# Westchester GIS - Shore Acres Peninsula Protected Wetland Pond 1960

A review of historical aerial imagery and GIS mapping was conducted to better understand changes in hydrology between McGid's Pond and Otter Creek. Historic aerial photographs from 1947 indicate that the current pond did not exist and that Otter Creek historically occupied what is now the pond basin. By 1960, aerial imagery showed the construction of a swimming pool within the former creek channel and the presence of an apparent earthen or structural barrier immediately north of the pool, creating what appears to be the present-day pond. These observations suggest that historical alterations to the drainage pattern may have reduced tidal exchange and water circulation within the pond. Additional engineering or hydrologic evaluation would be necessary to confirm this observation.
